Pavement Distress: A Case Study

20 km length of NH-52A was selected, starting from Nirjuli to Itanagar, to carry out survey of pavement distress. 50 important locations of 400 m interval in the highway were selected for the study. In this study, the observation showed that the most commonly found pavement distresses in the highway were pot holes, alligator cracks followed by raveling and edge failure. All the distresses found have values exceeding maximum limits. The most required probable treatments for surveyed distresses are overlay, patching and shoulder improvement. It was also observed that the side drainages were not maintained, cleaned and even absent in some places of the NH-52A.

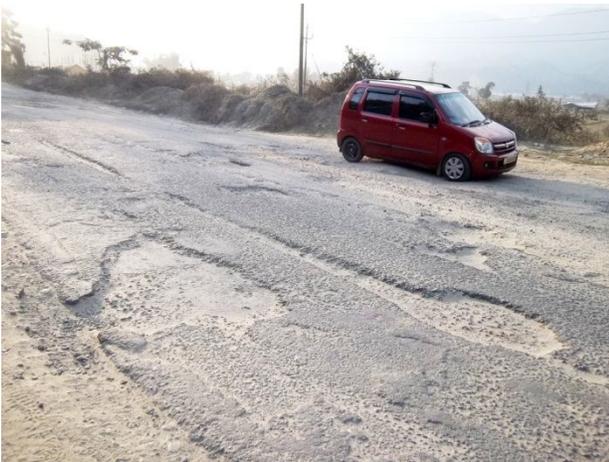
Figure 1. Pot holes and longitudinal cracks

No	Possible Causes	Probable Treatment
1	Loss of surface course due to heavy rainfall	Patching
2	Moisture entry to base course through a cracked pavement	Cut and patch

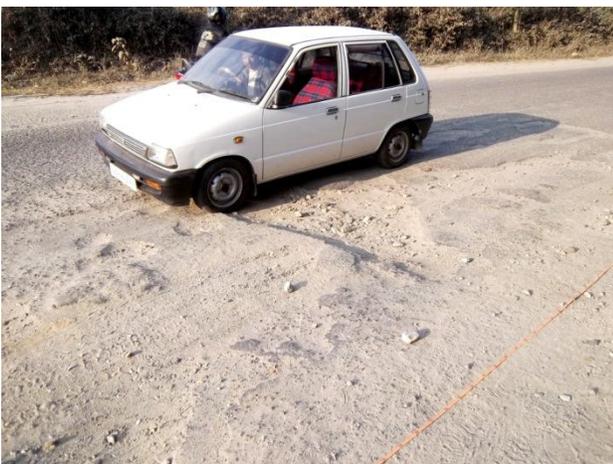
Figure 2. Deep pot hole consuming almost half of wheel radius (175mm deep)

The most commonly found pavement distresses were pot holes, alligator cracks followed by raveling and edge failure. The relative scale for measuring the severity of pot holes with respect to depth is: Low < 25mm deep; Moderate 25mm to 50mm, High >50mm deep. The average depth of pot holes found in NH-52A is 90-100 mm deep and the deepest pot hole found being 300 mm.

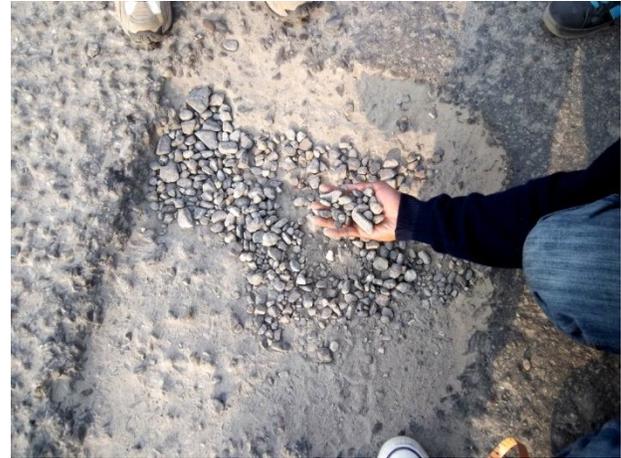
Figure 3. Raveling

No	Possible Causes	Probable Treatment
1	Insufficient bitumen content	Thin bituminous overlay
2	Poor adhesion of bitumen binder to aggregate particles due to wet aggregate	Thin bituminous overlay
3	Inadequate compaction or construction during wet weather	Thin bituminous overlay
4	Deterioration of binder and/or aggregate	Thin bituminous overlay

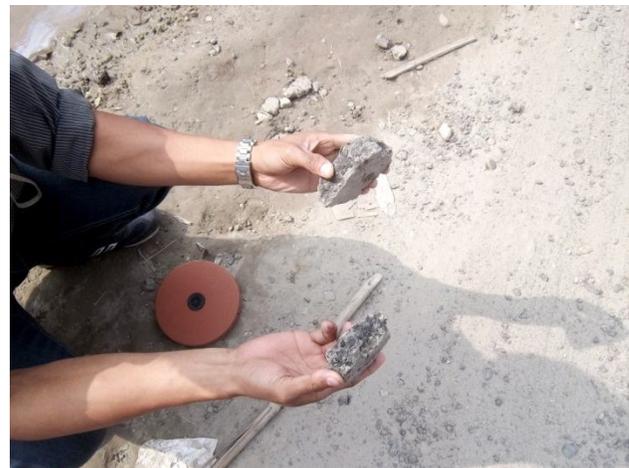
Figure 4. Pieces of cracked-out surface layer

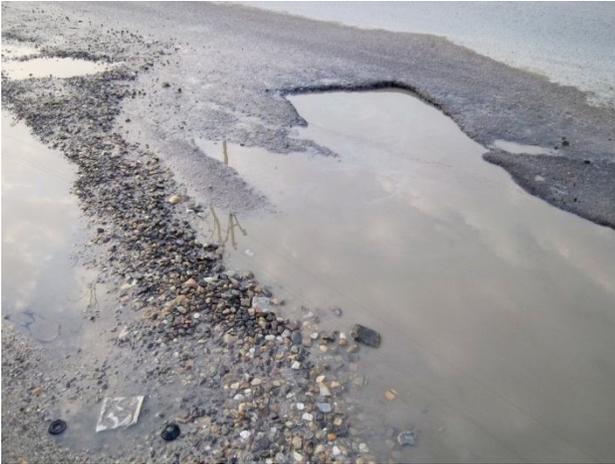
Figure 5. Big pot hole filled with drainage water and raveled aggregates (Naharlagun)

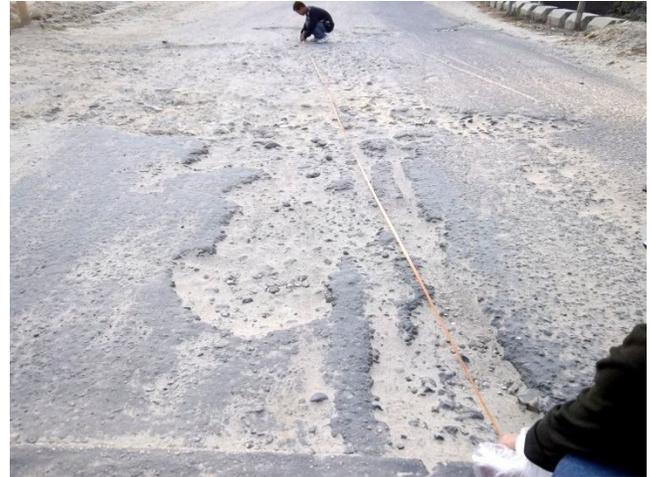
Figure 7. Total failure of pavement in Nirjuli

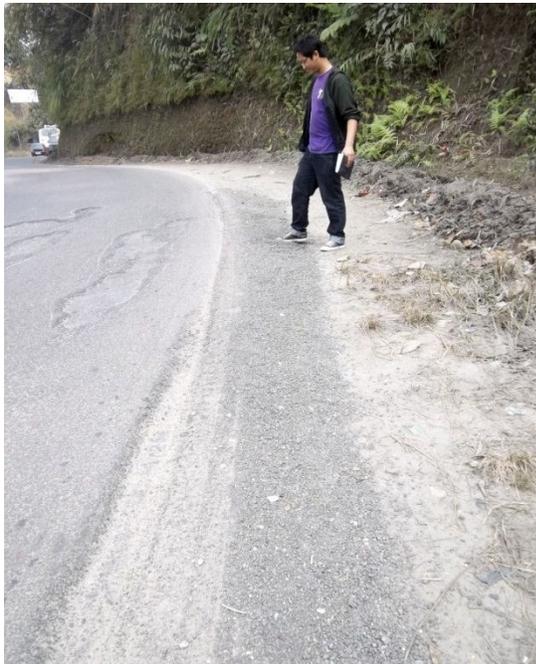
Figure 6. Total edge raveling failure- can cause accidents in case a vehicle take over from extreme corner as it's located on S-curve.

No	Possible Causes	Probable Treatment
1	Inadequate pavement width	Widen the pavement
2	Alignment which encourages drivers to travel on the pavement edge.	Pavement widening and realignment
3	Inadequate edge support	Shoulder strengthening
4	Seepage and heavy rainfall	Proper and efficient drainage

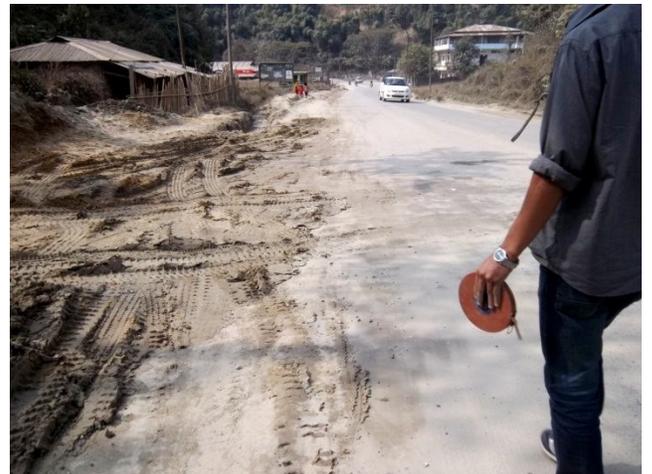
Figure 8. Mud on road side-Yupia. Not recommended as it reduces skid resistance of vehicles causing slipping

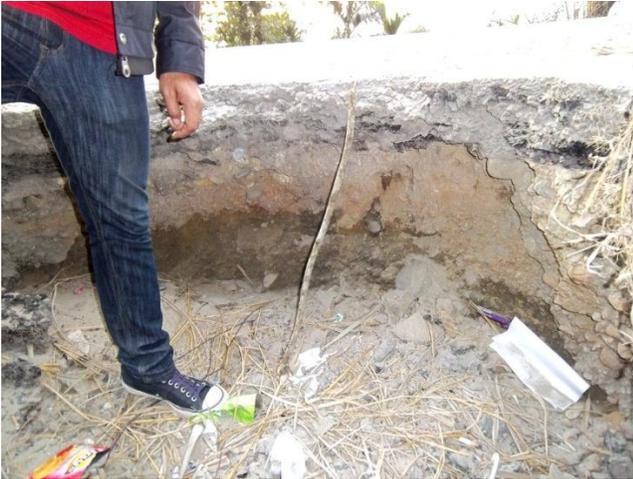
Figure 9. Failure on road side caused by subgrade failure
