# Structural Assessments of Concrete Piers in A Barrage Project Using Portable Ultrasound Non-Destructive Digital Indicator Tester

**Abstract:** Functional life of any barrage project depends on functional stability of the concrete piers. The piers are constructed using concrete of different grades. Its durability is dependent on various factors viz. speed of running water, its aggressivity, temperatures fluctuations etc. The endurance capacity of these piers against these adverse conditions is goes on reducing with passage of time. Gradually permeability of concrete increases which causes leaching of binding materials thus weakening the structure. Once such a phenomenon is observed in any such structures a vigilant periodic monitoring approach becomes mandatory. The suitable remedial measure to be adopted will depend on the observed degree of deterioration. In this paper effort has been made to assess the status of concrete in the piers of a barrage project using Portable Ultrasound Non-destructive Digital Indicator Tester.

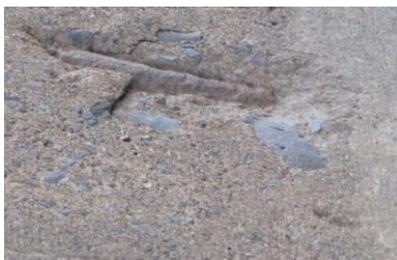
A In a barrage the endurance capacity of piers against adverse conditions such as speed of running water, its aggressivity, temperatures fluctuations etc goes on reducing with passage of time. The permeability of concrete gradually increases. causes leaching of binding materials thus weakening the structure (Fig. 1).

Fig. 1 Exposed reinforcement in piers due to spalling of cover

Once such a phenomenon is observed in any such structures a vigilant periodic monitoring approach becomes mandatory. The suitable remedial measure to be adopted will depend on the observed degree of deterioration. In this paper effort has been made to assess the status of concrete in the piers of a barrage project using Portable Ultrasound Non-destructive Digital Indicator Tester.

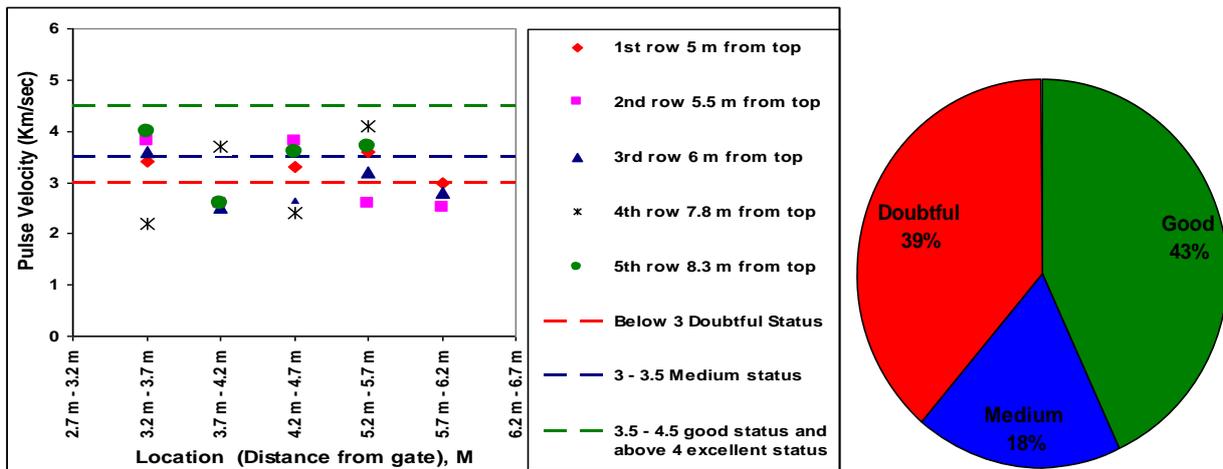
**Fig 4: Status of Concrete based on Pulse Wave Velocity Test**

The first grid point of each row was located at a horizontal distance of about 3.2 m away from the gate. The vertical distance of the I<sup>st</sup>, II<sup>nd</sup>, III<sup>rd</sup>, IV<sup>th</sup> & V<sup>th</sup> rows were 5.0 m, 5.5 m, 6.0 m, 7.8 m & 8.3 m respectively from top of the pier. The results are presented in the fig. 4. The pie chart clearly shows that 39% of the scanned area falls under doubtful region.

Further investigation to confirm the status of concrete is planned by extracting cores from these affected zones and testing these core samples in laboratory.

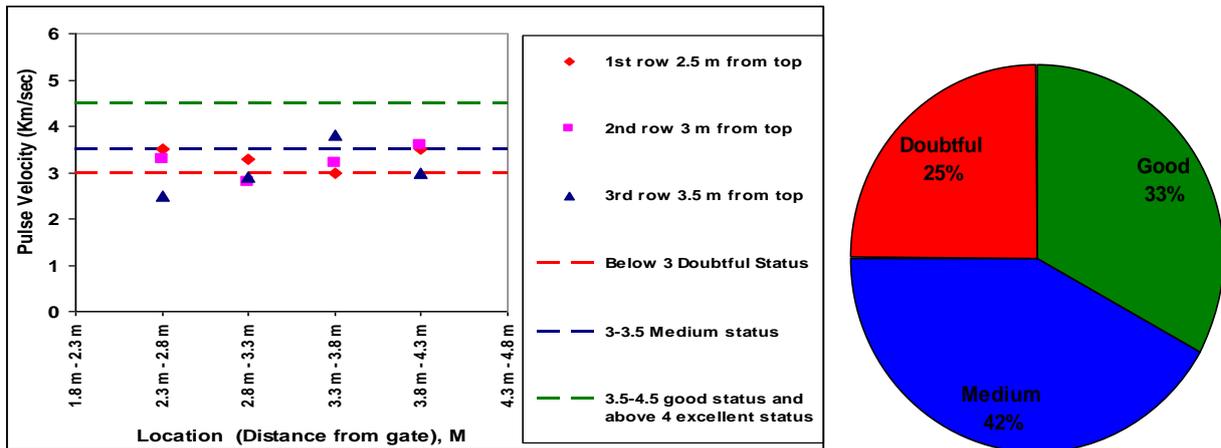
Fig 5: Status of Concrete based on Pulse Wave Velocity Test

The first grid point of each row was located at a horizontal distance of about 2.3 m away from the pier tail top. The vertical distance of the I<sup>st</sup>, II<sup>nd</sup> and III<sup>rd</sup> rows were 2.5 m, 3.0 m and 3.5 m respectively from top of the pier. The results are presented in the fig. 5. The pie chart clearly shows that 25% of the scanned area falls under doubtful region.

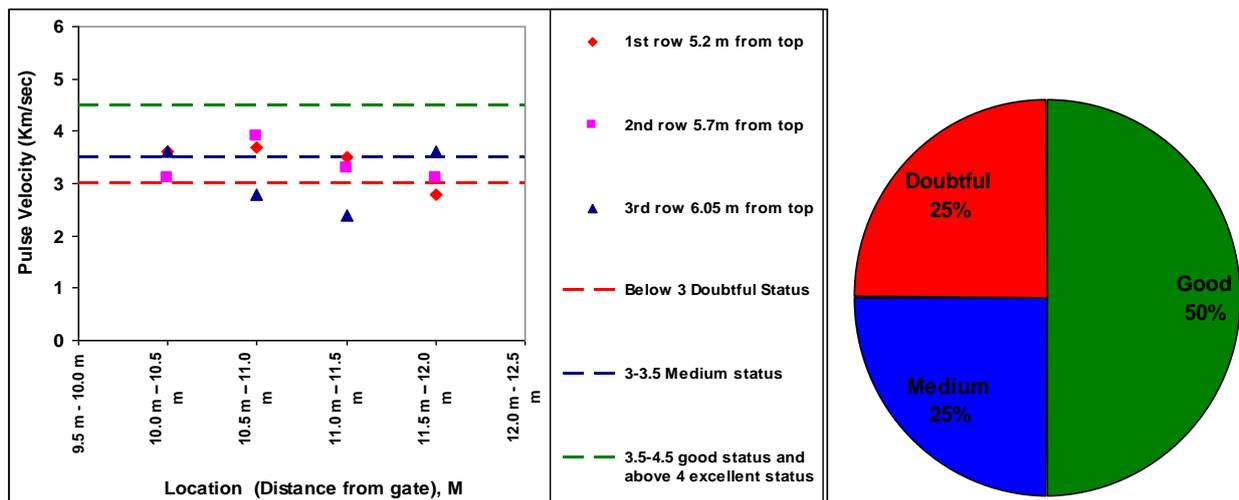
Fig 6: Status of Concrete based on Pulse Wave Velocity Test

The first grid point of each row was located at a horizontal distance of about 10 m away from the gate. The vertical distance of the I<sup>st</sup>, II<sup>nd</sup> and III<sup>rd</sup> rows were 5.2 m, 5.7 m and 6.05 m respectively from top of the pier. The results are presented in the fig. 6. The pie chart clearly shows that 25% of the scanned area falls under doubtful region

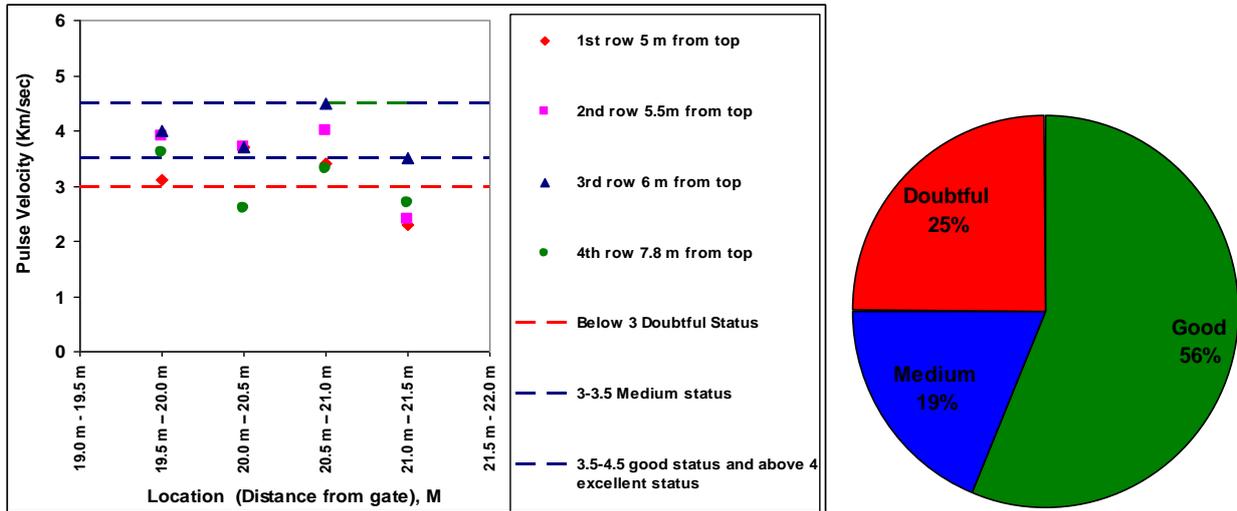
Fig 7: Status of Concrete based on Pulse Wave Velocity Test

The first grid point of each row was located at a horizontal distance of about 19.5 m away from the gate. The vertical distance of the I<sup>st</sup>, II<sup>nd</sup>, III<sup>rd</sup> & IV<sup>th</sup> rows were 5.0 m, 5.5 m, 6.0 m and 7.8 m respectively from top of the pier. The results are presented in the fig. 7. The pie chart clearly shows that 25% of the scanned area falls under doubtful region

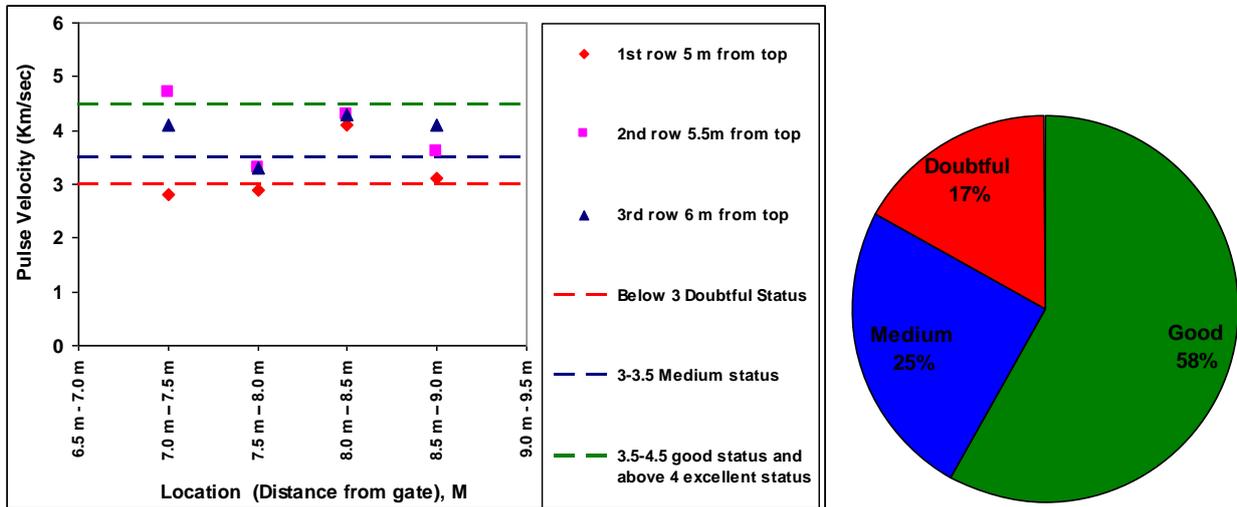
Fig 8: Status of Concrete based on Pulse Wave Velocity Test

The first grid point of each row was located at a horizontal distance of about 7 m away from the gate. The vertical distance of the I<sup>st</sup>, II<sup>nd</sup> and III<sup>rd</sup> rows were 5.0 m, 5.5 m and 6.0 m respectively from top of the pier. The results are presented in the fig. 8. The pie chart clearly shows that 17% of the scanned area falls under doubtful region

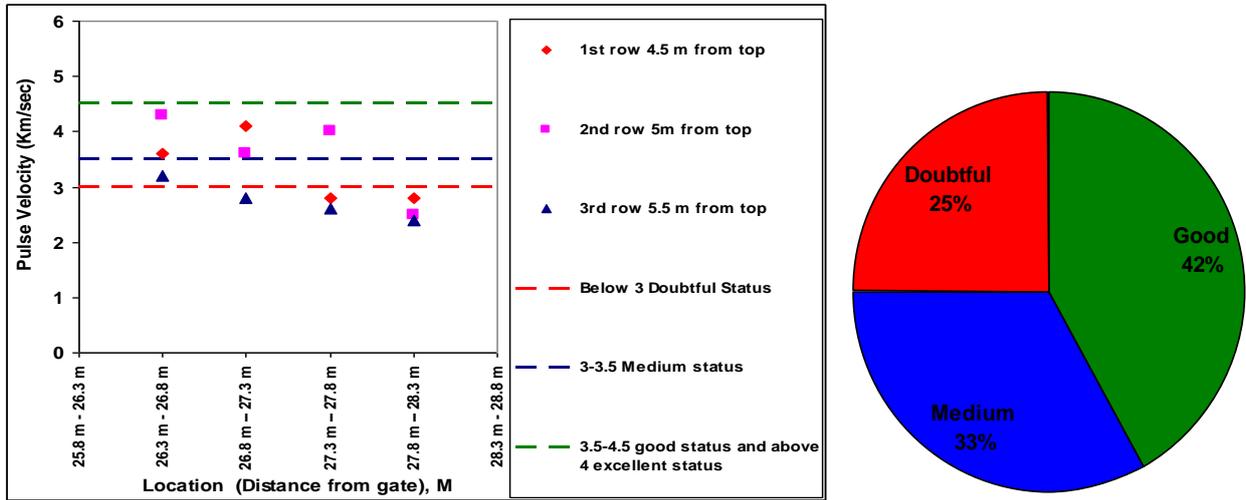
Fig 9: Status of Concrete based on Pulse Wave Velocity Test

The first grid point of each row was located at a horizontal distance of about 26.3 m away from the gate. The vertical distance of the I<sup>st</sup>, II<sup>nd</sup>, & III<sup>rd</sup> rows were 4.5 m, 5.0 m and 5.5 m respectively from top of the pier. The results are presented in the fig. 9. The pie chart clearly shows that 25% of the scanned area falls under doubtful region.

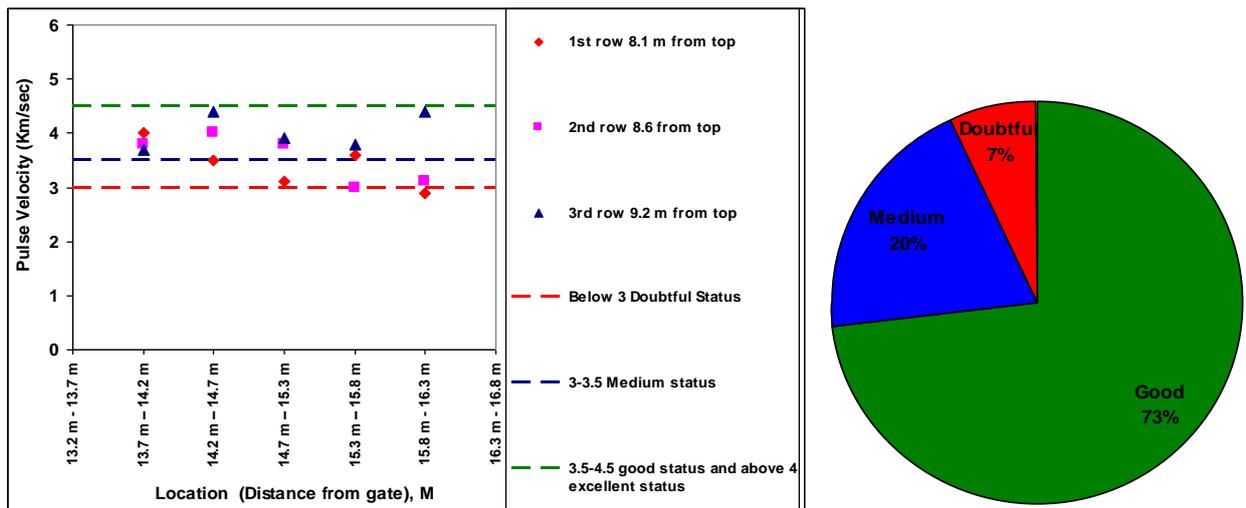
Fig 10: Status of Concrete based on Pulse Wave Velocity Test

The first grid point of each row was located at a horizontal distance of about 13.7 m away from the gate. The vertical distance of the I<sup>st</sup>, II<sup>nd</sup>, & III<sup>rd</sup> rows were 8.10 m, 8.6 m and 9.2 m respectively from top of the pier. The results are presented in the fig. 10. The pie chart clearly shows that 7% of the scanned area falls under doubtful region

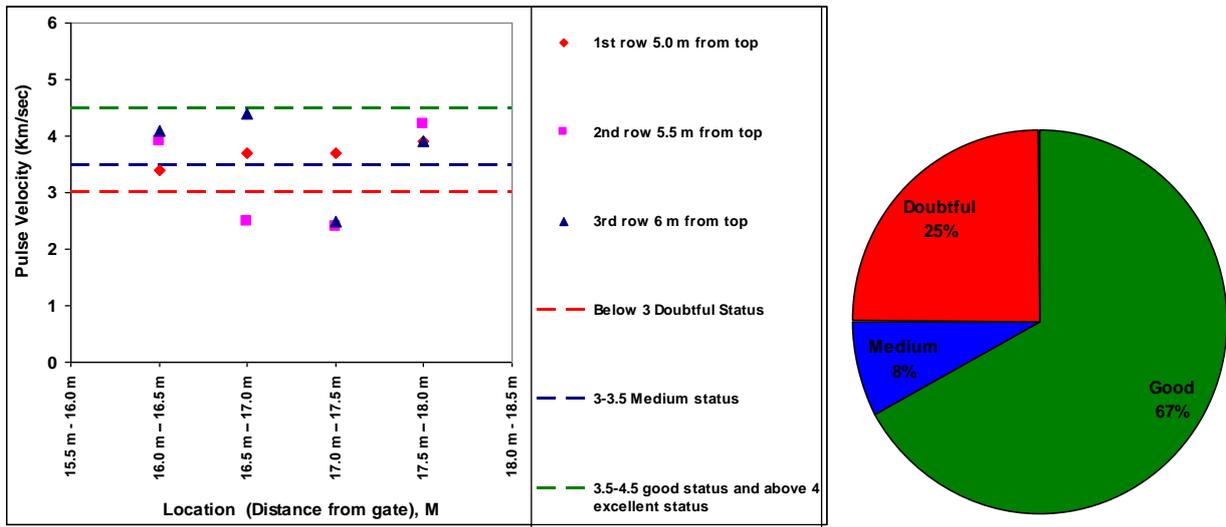
Fig 11: Status of Concrete based on Pulse Wave Velocity Test

The first grid point of each row was located at a horizontal distance of about 16 m away from the gate. The vertical distance of the I<sup>st</sup>, II<sup>nd</sup> and III<sup>rd</sup> rows were 5.0m, 5.5m and 6.0m respectively from top of the pier. The results are presented in the fig. 11. The pie chart clearly shows that 25% of the scanned area falls under doubtful region

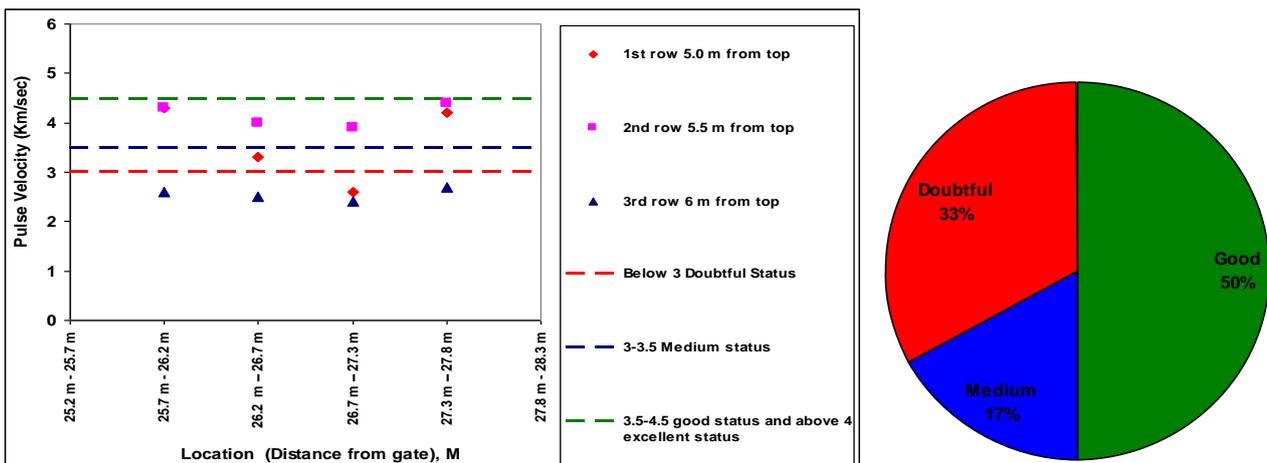
Fig 12: Status of Concrete based on Pulse Wave Velocity Test

The first grid point of each row was located at a horizontal distance of about 25.7 m away from the gate. The vertical distance of the Ist, IInd, & IIIrd rows were 5.0m, 5.5m and 6.0m respectively from top of the pier. The results are presented in the fig. 12. The pie chart clearly shows that 33% of the scanned area falls under doubtful region
