# To Arrive At Solution for Profile Distortion Problem Encountered During Heat Treatment Process of Gear Manufacturing Using Root Cause Analysis

The present work is carried out at Oerlikon Fairfield where difficulty occurred while developing a new helical gear. Profile fall was evident post heat treatment process and this affected required gear accuracy. The difficulty is related to correction of profile distortion problem occurring post heat treatment. When gears are hardened, distortion problems lower the quality of the gears and this initiated for finding the root cause of distortion by using quality tools like Root Cause Analysis Techniques so as to eliminate distortion problem by finding the root cause. Generally Failure Mode Effective Analysis(FMEA), Cause and Effect Diagrams, Shainin Methodology, Plan do check act cycle (PDCA), DMAIC(define-measure, analyze -improve-control) methodology are effectively used in industries to attain solutions for problems encountered during part's processing.

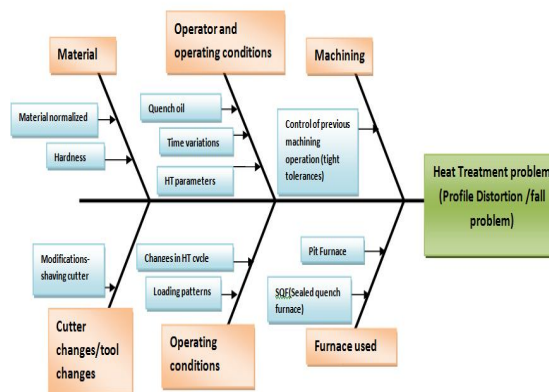
CAUSE AND EFFECT DIAGRAM (Profile distortion problem)

To identify the root causes, the Cause and Effect diagram is used to find the causes affecting profile distortion of the gear. Brain Storming sessions help in understanding the causes. Brain Storming sessions is also one of RCA tool. The groups of categories depicted in Fish Bone diagram help in understanding the probability of causes. From the diagram it is known that different causes that may be causing profile fall and each one of the probabilities have to be scrupulously checked so as to find the root cause. For this the problem of profile fall was evident after Heat Treatment Process.

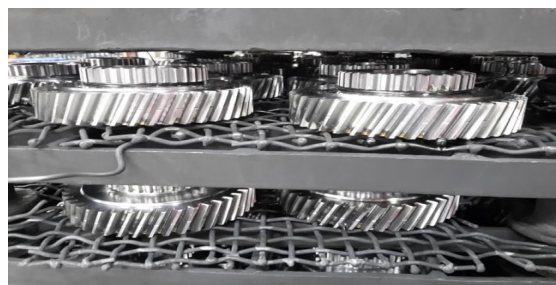
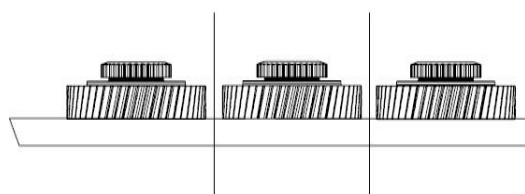
**HORIZONTAL LOADING**

Initially 5 parts were considered for regular Heat Treatment process cycle carried out in sealed quench furnace(SQF) and Loading pattern used was Horizontal. Entire Heat Treatment process consists of washing, Preheating, Carburizing, Diffusion, Soaking/Holding Time, Quenching/Hardening, Tempering. Hence with the same Heat Treatment process cycle, loading pattern was changed from horizontal to vertical/bar loading in order to solve profile fall problem. But this change did not help much as profile distortion was still evident even with vertical/bar loading pattern. Hence this option was dropped.

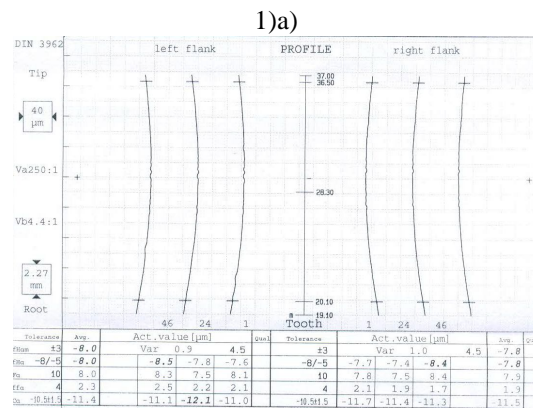
Initial shaving cutter 's graph.

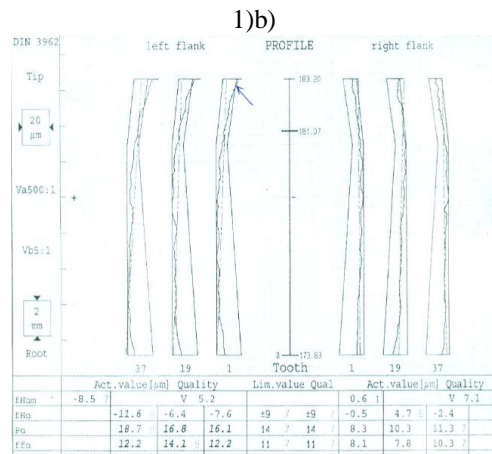
Part's shaving graph when initial shaving cutter was used.

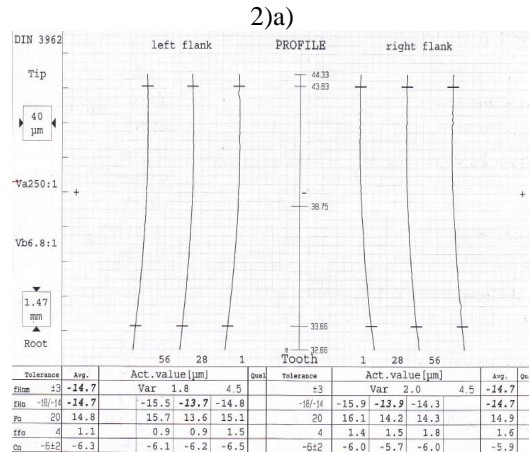
shaving cutter's graph after 1st modification.

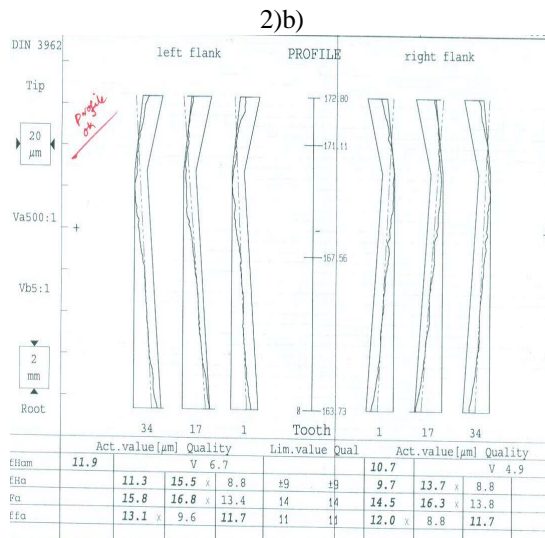
Part's Shaving graph attained for 1st modification of shaving cutter and improved shaving graph is evident.

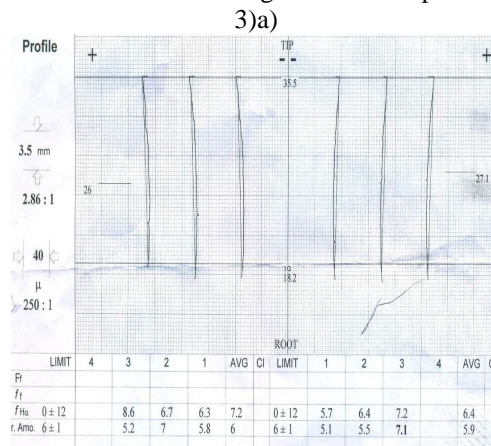
Shaving cutter's graph- 2nd modification of shaving cutter. This was done as heat treated part's graph was still falling on the border of K sheet and hence 2nd modification was required.

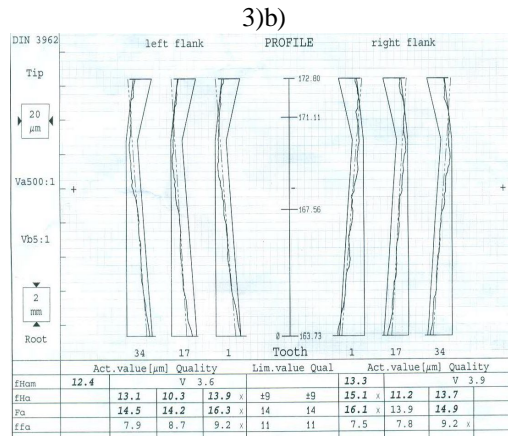
Part's Shaving graph for 2nd modification of shaving cutter. Below graphs show the graphs of parts(gears) that were shaved using 1st cutter, 1st modified shaving cutter and 2nd modified shaving cutter after the same parts(gears) which were shaved and then heat treated.

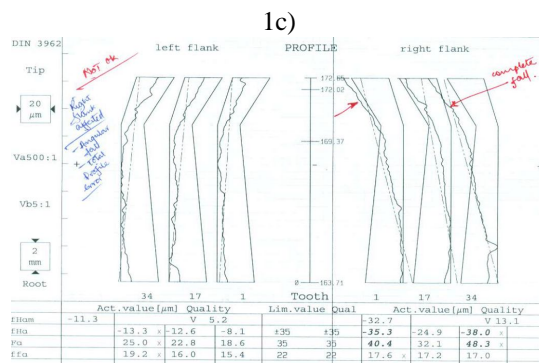
Complete fall of profile/ involute of gear noticed when initial shaving cutter was used for shaving and the same part being heat treated. The fall of graph explains the amount of profile distortion occurring after Heat Treatment process i.e. after the part was heat treated. This is unacceptable and hence changes were required to be done in shaving cutter itself as control of part's profile fall was inevitable. Hence shaving cutter was sent for modification with changes and amount of modifications required. Modification details are shown in previously explained cutter changes diagrams.

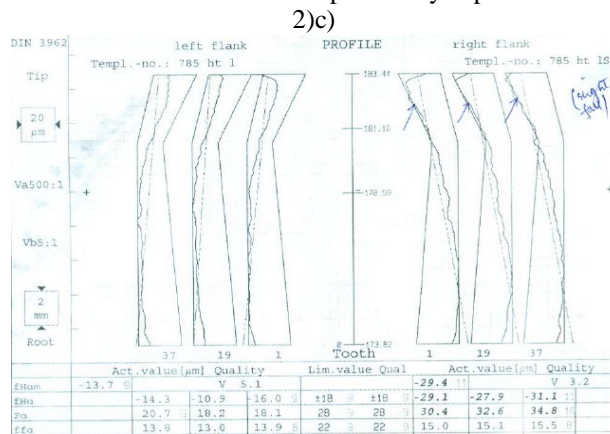
Fall of profile/ involute of gear noticed on the border of K sheet when 1st modified shaving cutter was used for shaving and the same part being heat treated. Improved graph of profile is witnessed when compared to the later heat treated part's graph. The profile fall is seen on the border of K sheet which depicts still improvement was required to attain the final graph within the K sheet. Hence 2nd modification for shaving cutter was imperative in order to achieve better and acceptable results.

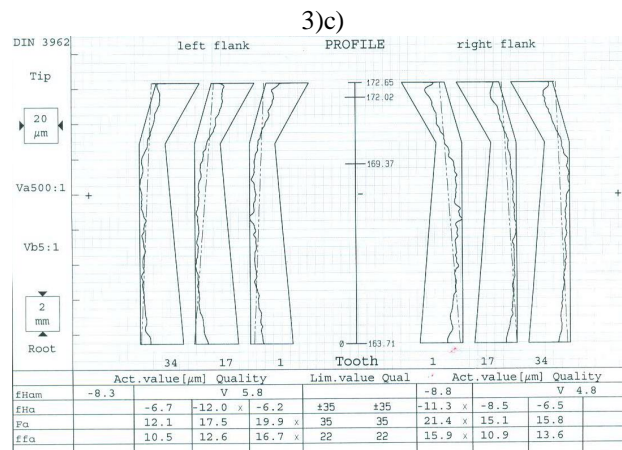
Correct or as required profile/ involute of gear noticed within the K sheet when 2nd time modified shaving cutter was used for shaving and the same part being heat treated Successful results were achieved as gear profile was within the K sheet.

The graph shows the left flank and right flank of gear within the K sheet.

Hence heat treatment distortion problem ( profile fall problem) was solved via successful modifications of shaving cutter after carrying out various experiments.
