A Novel Methodology to Debug Leakage Power Issues in Silicon- A Mobile SoC Ramp Production Case Study

ABSTRACT: As the world is moving toward DSM era, understanding silicon behavior is becoming more and more challenging. Models are getting complex and yet not able to reflect the actual silicon behavior. Hence some of the silicon issues cannot be replicated in circuit simulations. The problems found on silicon require the understanding of various tools and techniques available to observe and modify the die. A good understanding of these techniques and debug methodology is required to meet Time to Market goals.

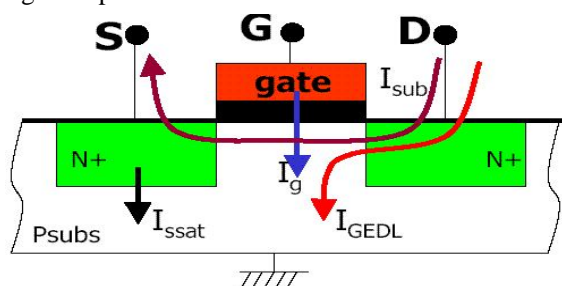
Figure 1: Different leakage in CMOS device

Figure 1 explains the various leakage components in a CMOS device

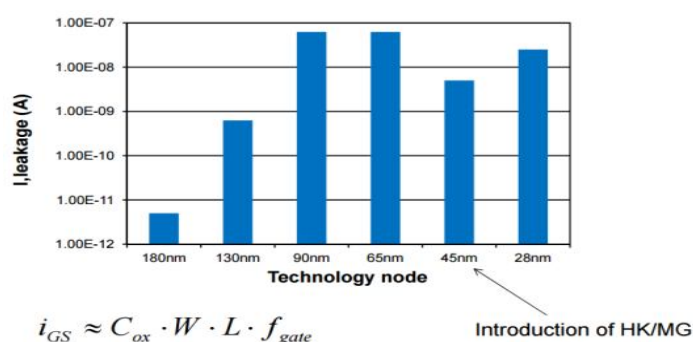
Figure 2: A typical leakage numbers in various technology nodes

As the technology shrinks operating voltage decreases but the threshold voltage does not decrease proportionally, which leads to large leakage in deep submicron (DSM) designs. Starting 90nm & moving towards 14nm technologies, leakage is a major component of the total power. Figure 1a indicates the typical leakage numbers for various technology node. The

significance of leakage number can be appreciated by noting that the leakage current alone will be 10 mA for a design with 15 million transistors in 28nm tech node.

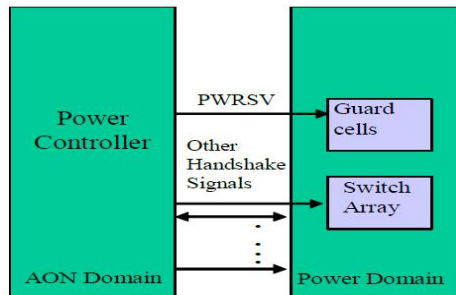
Figure 3:Interfacing of different power domains

The leakage power saving strategy requires special cells, namely switches and guard cells to be part of the standard cell library. The switch cells are used to cut-off power to the logic gates in shutdown mode. The guard cells need to be placed on signals that cross power domains, to ensure that all inputs of powered domain are driven. In the absence of guard cells, the inputs of cells, in powered domain driven by the output of powered-off cell, will be floating. The guard cells essentially act as tie off cell in power saving mode and as buffers in the normal functional mode. The guard cells thus are buffers with an additional control signal, called PWRSV. The commonly used guard cells are TIE0 that ties a node to low (when PWRSV is high) and TIE1 that ties a node to high (when PWRSV is high). Figure 2 summarizes the power conservation architecture.

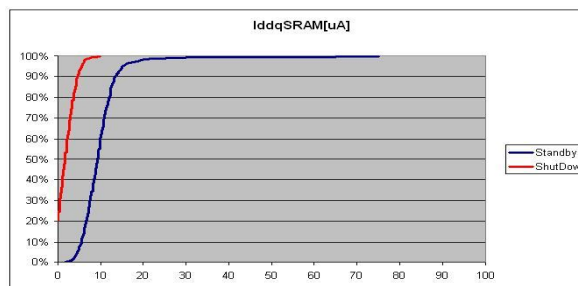
Figure 4:Plot of VDDram IDDQ

Figure 4 shows the IDDQ current variation, in RAMs, in standby mode and shutdown mode. Note that the standby mode current curve and shutdown mode current curve don't intersect. The distance between two curves indicates power saved.

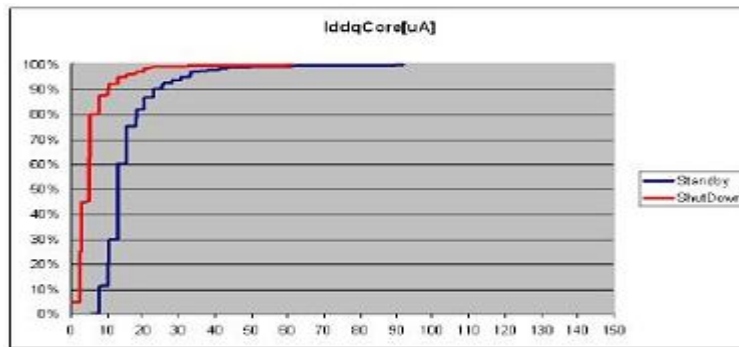
Figure 5: Plot of VDDcore IDDQ

Figure 5 shows the logic power domain IDDQ variation in standby mode and shutdown mode. Note that the tails of shutdown IDDQ curve intersects the standby IDDQ curve. The plots indicate that shutdown mode current for RAM power domain was close to estimation while those for logic power domain were way off. The analysis of the two plots concludes that the VDDcore domain only has high IDDQ issue. The plots also helped us rule out problem in switch cell because the same switch cells are used in RAM and logic power domain. Thus the problem statement was reduced to finding floating nodes within VDDcore power domain.

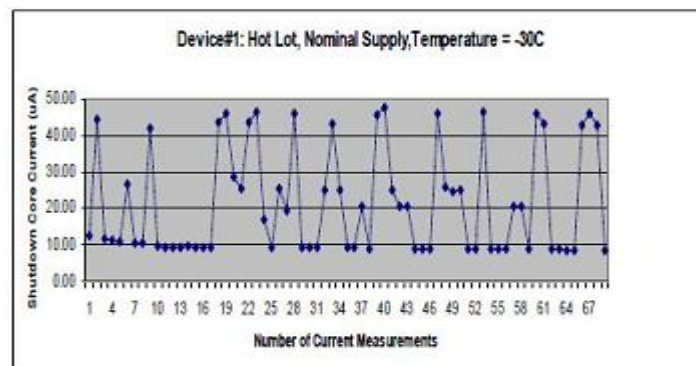
Figure 6: Shutdown IDDQ variation with power cycling

The detailed study of bench set-up indicated that the device was not coming out of a wait state. This resulted in the device always being in a known state on every power cycle, resulting in no current variation. The device required a particular transaction on the peripheral interface to come out of the wait state. On further bench experiments with the desired transaction the shutdown IDDQ current was measured. Figure 5 depicts the result of current measurement with power cycling on a single device with required transaction on the peripheral.

The above figure proves our hypothesis of floating nodes being the cause of high IDDQ variation in shutdown mode.

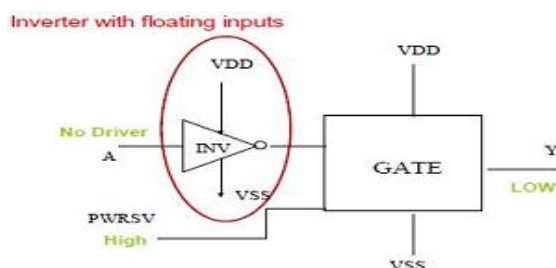
Figure 7:TIE0 guard cell transistor schematic

Figure 7 clearly shows a high IDDQ scenario in TIE0 cell when “A” input is floating and VDD power supply is present. In the actual design, the input “A” is floating during shutdown mode because it will be driven by a powered off logic. To fix this in silicon, conventional FIB (Focused Ion Beam) approach was first looked at. In DSM technology it is very difficult to FIB lower metal layers which ruled out fixing all the 79 cell instances after careful analysis of layout and design a reduced list of 12 FIB points was identified. The FIB effort was estimated as 40 hours for this reduced list. The FIB expenses are around \$300/hr. The FIB option was ruled out since the cost of \$12K per device was not justified given the low probability of FIB success even for a reduced fix. Hence there was a need to identify alternate methods and technology to fix this issue conclusively.

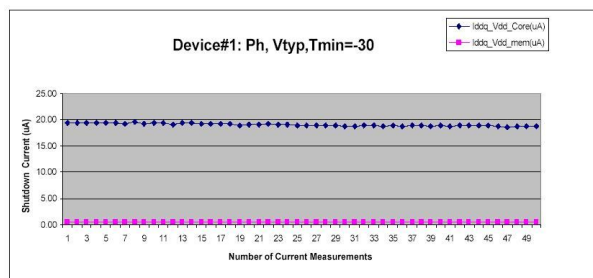
Figure 8:Shutdown IDDQ variations in power cycling with patch download for value 0x0000

Further bench results with and without transaction were correlated to different voltage levels at “A” input of TIE0 cells prior to shutdown mode entry. A detail analysis of software sequencing of the device with and without the transaction on peripheral revealed that 16 out of 79 TIE0 cells could have random values after power-up. The values on the inputs of 16 TIE0 inputs could also be controlled through special software patch. The Shutdown currents were measured with different known values forced on the 16-TIE0 input nodes through software patch. Figure 7 shows the IDDQ current values in shutdown mode with value of 0x0000 on these 16 TIE0 cells prior to shutdown mode entry.

As shown the multiple current readings are now constant which provides that TIE0 cells in AON domain caused the IDDQ problem.

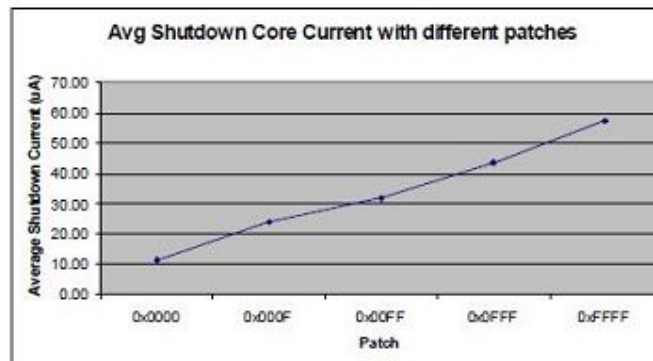
Figure 9: Shutdown IDDQ variation in power cycling with different patch download

Figure 9 shows IDDQ current variation with different values on the 16 TIE0 cells. Figure 8 shows a linear increase in IDDQ current with increase in number of TIE0 cells having “A” input as high before shutdown mode entry. This confirms the hypothesis of TIE0 to be one of the root causes of the problem. We still had to rule-out the presence of other floating nodes. To rule out any other floating node other than TIE0 silicon debug technique, EMMI was used. EMMI technology [3] is used to identify the hot-spots in the design that could indicate presence of floating nodes in silicon. EMMI technique essentially works on the principle of sensing heat emission to identify hot spots on silicon. The logic that has floating nodes will draw high current, resulting in excess power dissipation subsequently resulting in temperature increase in that region. The EMMI images thus indicate hot spots as red or yellow dots in the image. The EMMI requires currents to be in hundreds of microampere to reliably detect hot spots.

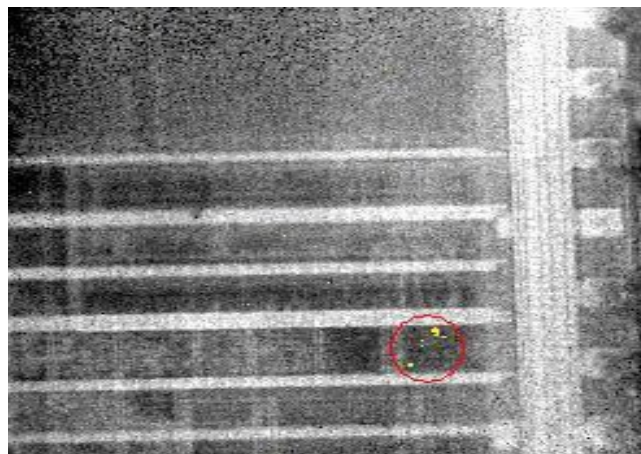
Figure 10: EMMI image at Vcore=1.3V

Figure 10 shows the EMMI images with nominal voltage applied. As seen the image does not give reliable results since the current is only about 140 uA. To get a reliable image the current had to be increased significantly. It was proposed to select devices from strong process corner and also increase the applied voltage to achieve higher IDDQ current.

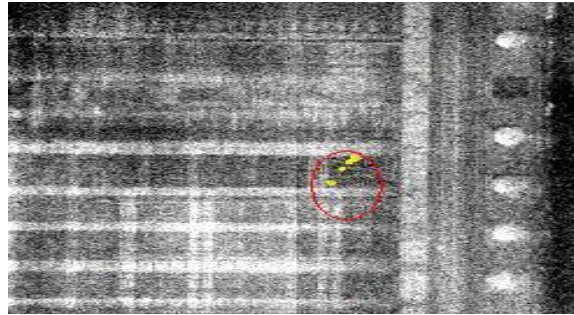
Figure 11:EMMI image showing hot Spot in the device at $V_{core}=1.5V$

Unit-2 (999 uA@1.5V)

Figure 12 shows the location of the same 16 TIE0 cells in layout, which were expected to be the culprits from patch, download experiment. By matching the hot spot (Figure 10) and the layout (Figure 11) it was confirmed that TIE0 was the only cause of high IDDQ current.
