COMPARATIVE EFFICIENCY OF RAINWATER HARVESTING BY SOME TYPES OF MICROCATCHMENTS

H. A. El Atta^{*1}; I.M. Aref¹; T. Alshahrani¹; A. Alazba²; ¹K.A. Ibrahim

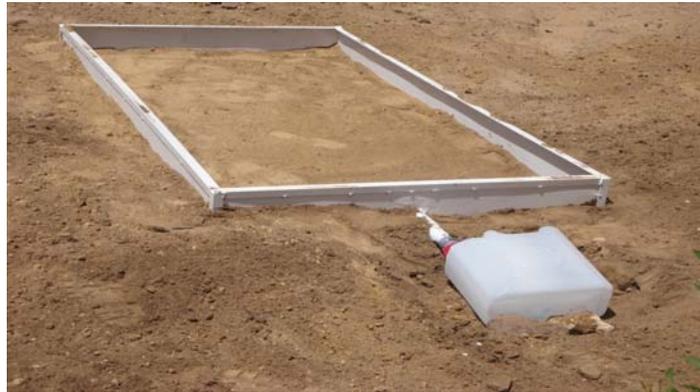
Fig. 1 The study plot

Two x one m plots [22] [23] [24] were prepared from galvanized iron and inserted 10 cm deep into the soil in terraces and semi-circular bunds. They were connected to a plastic container via a plastic hose for the collection of runoff and sediment and measurements of infiltration and bulk density (Fig. 1). The plots were replicated thrice/treatment [24]. Rain intensity, infiltration and soil physical properties could be affected by the plot parameters [25]. However, the results from small plots (1 m²) were comparable to larger plots (30-40 m²) and small plots are recommended for exploratory soil erosion studies [22]. Treated and control plots (terraces and semi-circular bunds) were monitored during March 2011-March 2012 and the following parameters were measured/plot:

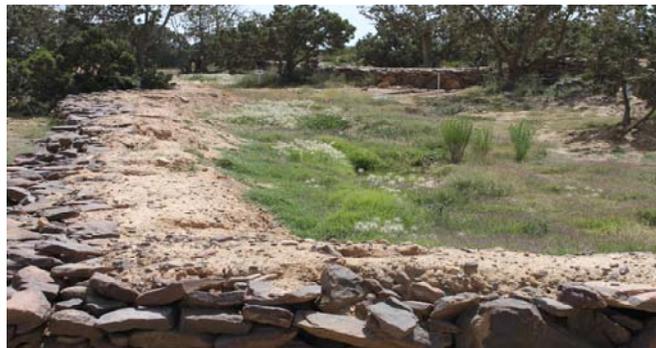
Fig. 8. Dense ground vegetation on a repaired terrace.

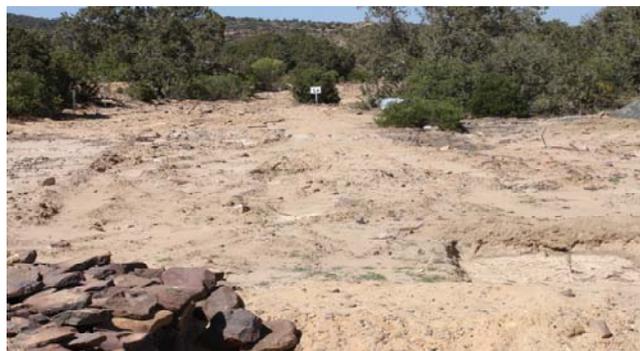
Fig. 9. Damaged terrace with poor ground vegetation.
