Mechanical and Microstructural Characterization of a Hadfield Cast Iron Subjected to Wear Regimes

Research Article

The objective of this work is to mechanically and microstructurally characterize a Hadfield cast iron of national production subjected to wear regimes in the mining industry.

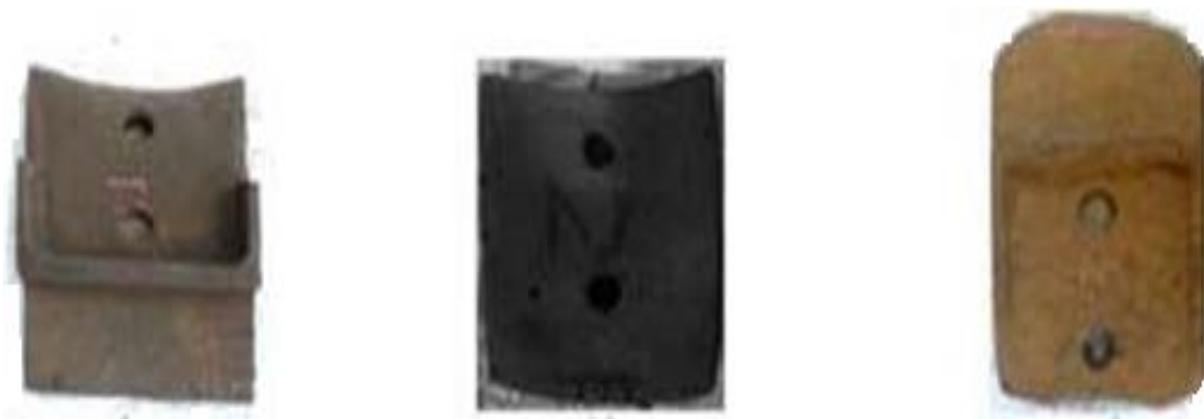
Figure 1. Samples of the alloys virgin alloy and worked alloys.

Mechanical preparation of specimens: The preparation and cleaning operations were carried out in a specific sequence. In order to obtain flat surfaces with the least possible deformation, the specimens were cleaned over the entire surface and sectioned on a CM 260 type cutting machine (Echo RD brand). Three samples were taken, two from damaged parts and one from unplaced parts in operation (Figure 1), including those with the highest durability, which made it possible to compare the behavior of the material in both cases.

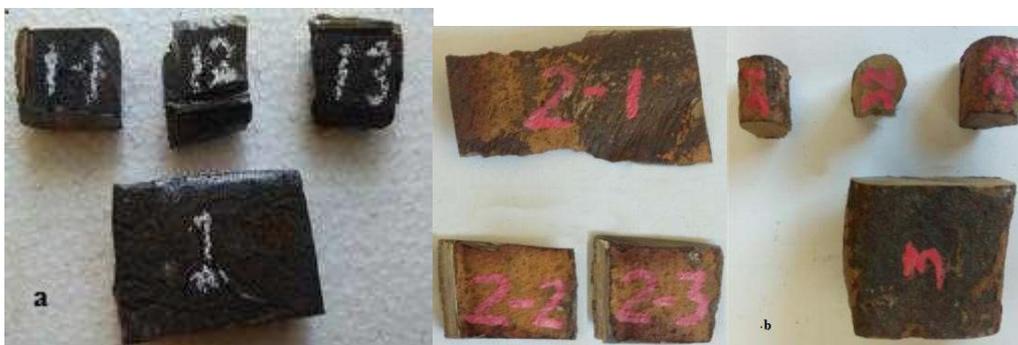
The specimens were cut (Figures 2a and 2b), with the use of a cutting disc, with abundant cooling to avoid heating due to friction effect, because the temperature produced can alter the structure, at least on the surface obtained [7].

Figure 2. a) Virgin alloy; b) Samples of the alloys removed from service.

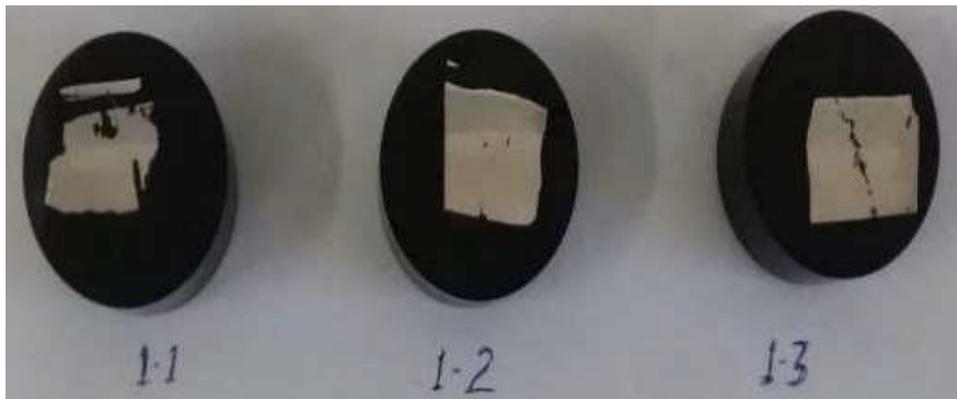
Preparation of samples for microstructural observation: Prior to the roughing and polishing operations, it was necessary to encapsulate the samples (Figures 3 and 4), for better handling of the samples and then its were marked for their subsequent identification, so as to allow working with them without the appearance of unwanted surfaces that distort the image under the microscope. This procedure was carried out by means of a machine designed for this purpose (Echo RD, type MP 350 A). Black phenolic resin was used, with a melting temperature of 150°C-170°C, with a permanence of 6 min-8 min, then they were cooled in the mold.

Figure 3. Encapsulated samples of the virgin alloy.

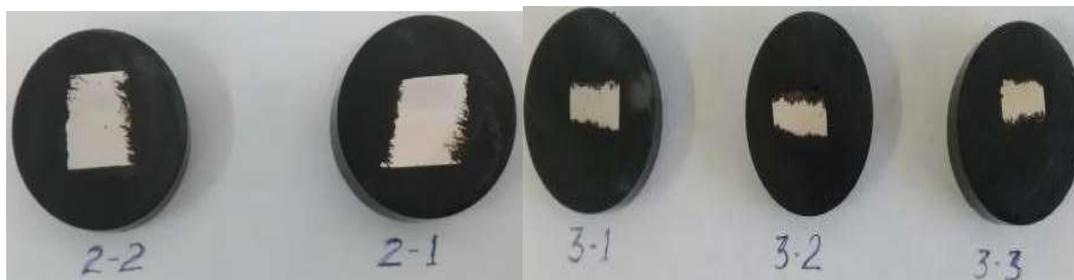
Figure 4. Encapsulated samples of the alloys out of service.
