Analysis and Performance of Automobile Engine Components Considering Thermal and Structural Effects

Abstract: This paper presents an investigation report of effect of various parameters which affect the performance of an automobile engine. Almost all internal combustion engines have at least one connecting rod to transmit the thrust of the piston to the crankshaft, and as the result the reciprocating motion of the piston is translated into rotational motion of the crankshaft. From the viewpoint of functionality, connecting rods must have the highest possible rigidity at the lowest weight capable to withstand varying loads. It has been found that structural failure of various components results in engine missing and starts producing noise and vibration during racing, mileage gets affected and black or white smoke arise also pickup gets reduced. In automobile industry damaged or broken parts are generally too expensive to replace or repair especially in case of engine. In this concern we presented detailed analysis of causes along with preventive maintenance suggestion schedule for better engine life.

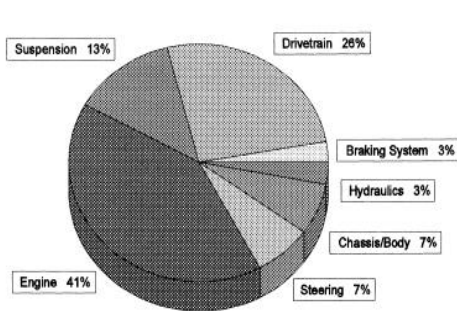
Based on an analysis of seventy automotive component failures received for investigation the distribution of component failure and the distribution of causes are given in Fig 1 and 2 respectively. From this it can be seen that the most common component failure is that of the engine (41%) and that the most common cause of failure is abuse (29%) [1]

Fig.1. The distribution of component failures

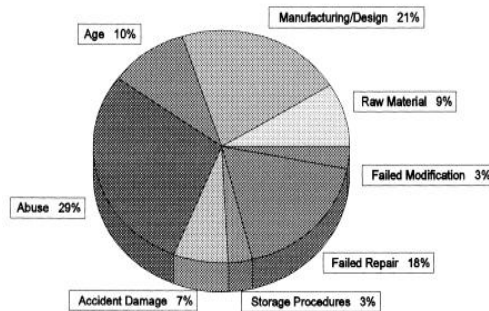
Fig.2. The distribution of causes of failure

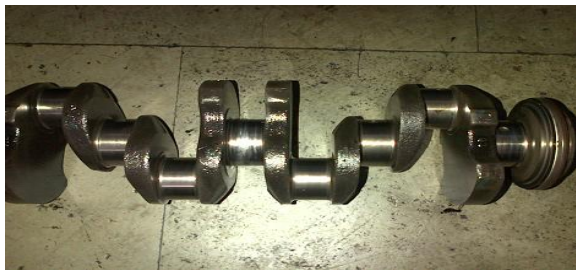
Oil clearance near the parting line is decreased to such an extent that metal-to-metal contact between bearing and journal takes place, resulting in areas of above-normal wear. Also, improper seating between the bearing back and the housing bore may be present which hinders proper heat transfer causing localized heating of the bearing surface and thus reducing fatigue endurance.

Fig.3. Scratches on upper main bearing half in crank shaft

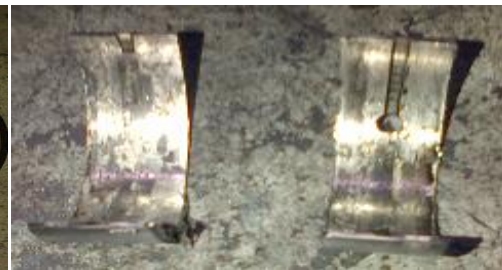
Fig.4. Scratches on upper main bearing caps

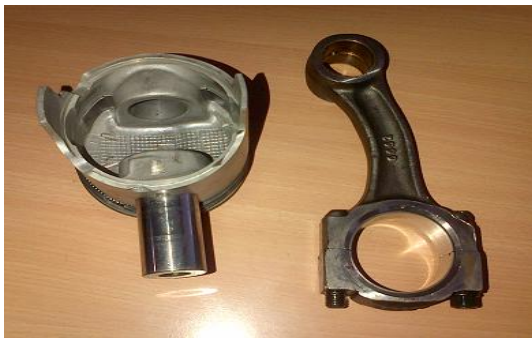
Whenever driver passes the car over the stored water on the ground and if there is chances of water coming inside in engine through exhaust pipe (silencer) then in that case hydrostatic locking of engine condition will observed. Figure 5 shows the hydrostatic lock effect on the connecting. Due to this only connecting rod is observed to be affected there is no any defect on piston is observed.

Fig.5. Hydrostatic Lock Effect

For avoiding hydrostatic lock it is mandatory to pass over that kind of situation by putting vehicle in first gear, press 50% of accelerator paddle without fluctuation and slowly controlling through the clutch and cross the situation

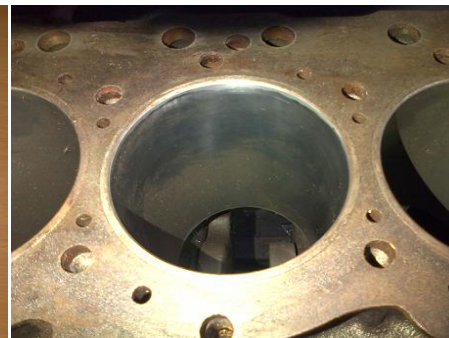
Fig.6. Cylinder in good condition

Also it was observed that it does not affect cylinder as shown in Figure 6

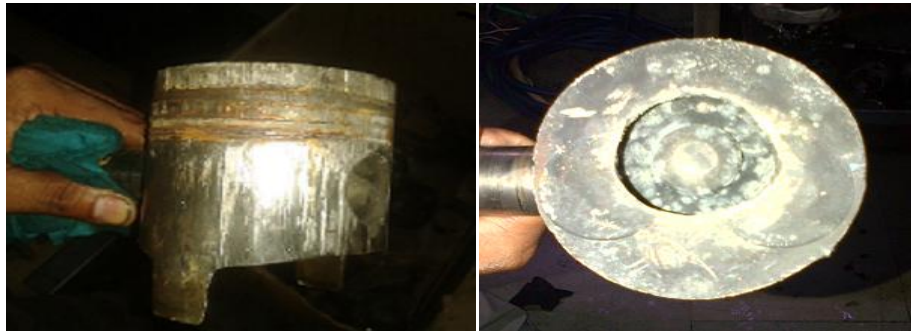
Figure 7 shows piston assembly highly overheated due to lack of lubricants and failure of the engine cooling system.

Fig.7. Worn out piston due to overheating

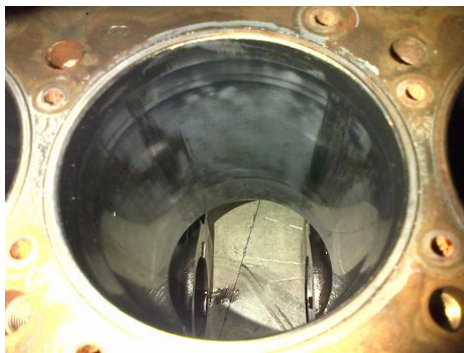
Consequent effects of piston can also be visualized on piston sleeves are shown in next Figure 8.

Fig.8. Worn out cylinder surface

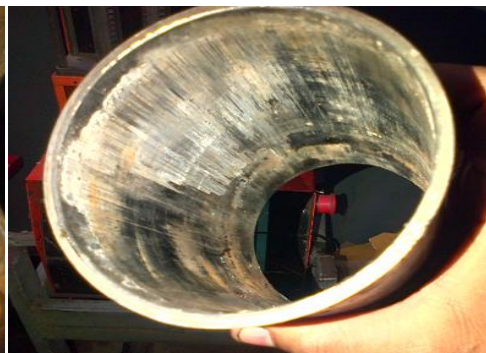
Fig.9. Worn out piston sleeves due to seizing of badly overheated piston
