POST CONSTRUCTION DIAGNOSIS OF REINFORCEMENT IN THE ELEMENTS OF HYDRO ELECTRIC PROJECT

Abstract:The hydro projects envisage various concrete structure viz. dam body, foundation galleries, inspection galleries, power house complex, headrace tunnel, tail race tunnel etc. which are constructed using concrete linings of different grades. Its durability is determined by various factors viz. aggressivity of surrounding water, temperatures fluctuations etc. If the water happens to be soft it is injurious to the useful life of concrete as it leads to leaching of lime. Leaching is a phenomenon that is caused by water migrating through the permeable concrete. The permeated water causes corrosion of reinforcement leading to weakening of structure. Once such phenomenon is observed in any such structures a vigilant periodic monitoring approach becomes mandatory. The suitable remedial measure to be adopted will depend on the observed degree of deterioration. In this paper effort has been made to diagnose degree of corrosion of reinforcement at different locations in the power house complex and dam foundation gallery of one of the projects in the state of Himachal Pradesh, India using Half Cell

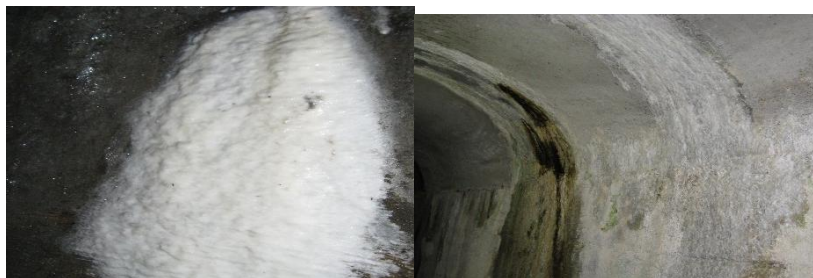
Corrosion problems are very common in almost all aspects of technology resulting in cropping of variety of problems. Post construction corrosion damage in the reinforcement is an enormous economic liability. Various elements in any hydroelectric project are constructed using concrete linings of different grades. The water in Himalayan Rivers is generally soft which causes leaching of lime (Fig. 1, 2).

Fig. 1 White Leachate deposit in the Power House Complex Fig. 2 White, Black and Brown Leachate deposit in Dam Gallery

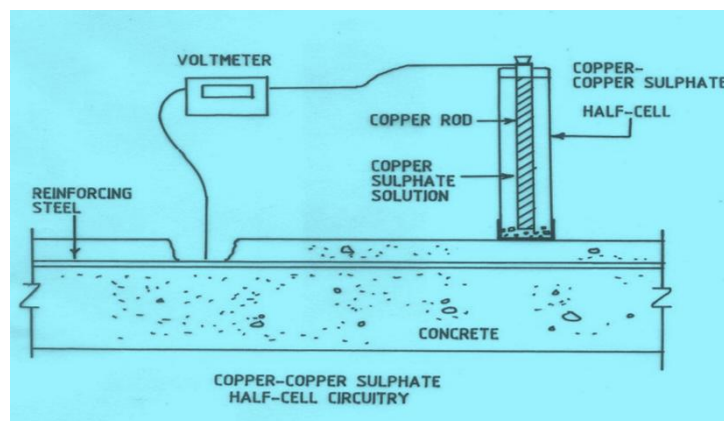
Figure 3 Copper- Copper Sulphate Half- Cell

The half cell consist a rigid tube composed of dielectric material that is non-reactive with copper or copper sulphate, a porous wooden or plastic plug that remains wet by capillary action, and a copper rod that is immersed within the tube in a saturated solution of copper sulphate. The solution is prepared using reagent grade copper sulphate dissolved to saturation in a distilled or deionized water. An electrical junction device is used to provide a low electrical resistance liquid bridge between the surface and the half cell, is normally a sponge. Electrical contact solution is made from normal house hold detergent. Measurements are made in either a grid or random pattern. The potential risks of corrosion based on potential difference readings [3] are presented in Table 1.

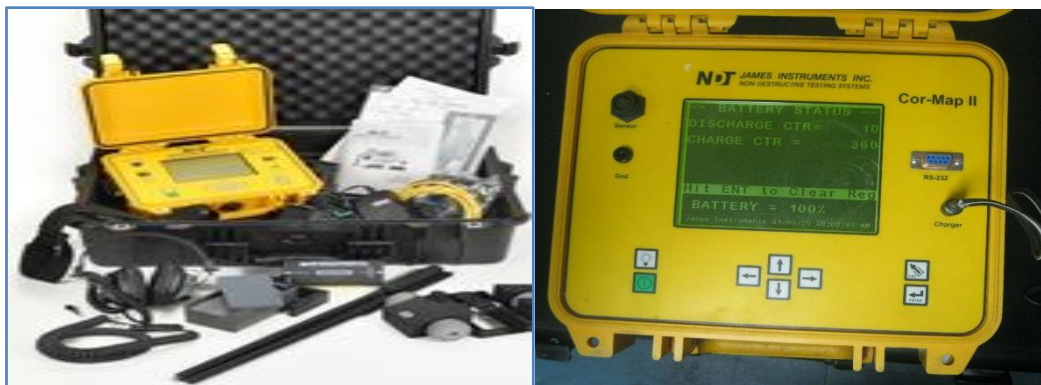
Micro Cover Meter

Half Cell Surveyor

Figure 4.Equipments Deployed for Investigation

The micro cover meter has been used to locate the rebar [4]. The concrete surface was examined for the exposed rebars/or got exposed to get a reference point. Surface was made wet and observation locations were marked on the surface [5]. The pre-activated Cu-CuSO₄ Half Cell was used to take observation.

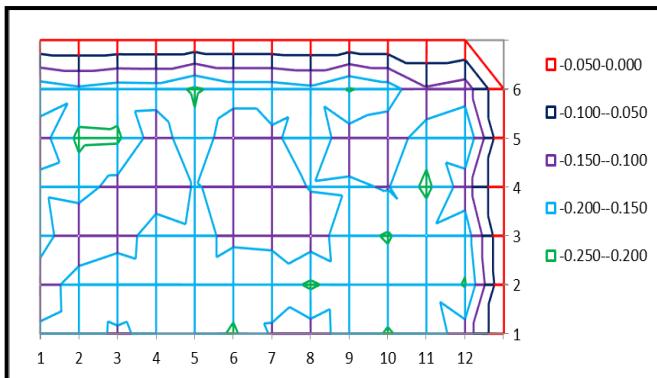
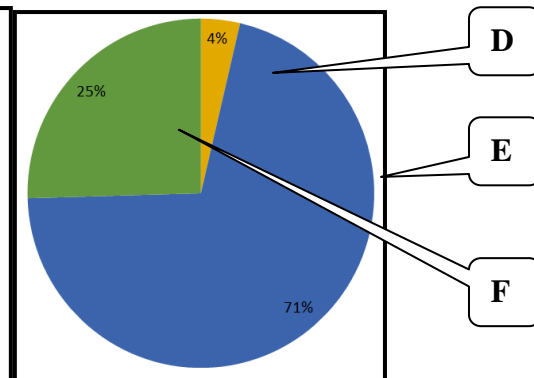
The Test results are presented as contour map (Fig. 5) and pie chart (Fig. 6). It is observed that 4% area falls under category 'D', 71% area falls under category 'E' and remaining 25% area falls under category 'F'.

Fig. 5 Contour Map Showing Corrosion Status of Scanned Area in Scanned Area

Fig. 6 Pie Chart Showing Degree of Corrosion

Referring Table 1 it is observed that in 4% area status of corrosion is uncertain while in remaining 96% area, 90% chances are that there is no corrosion activity at present.

Since indications of deterioration of concrete and reinforcement have been observed it is recommended that periodical monitoring of both the sites should be carried out using Non Destructive Tests.

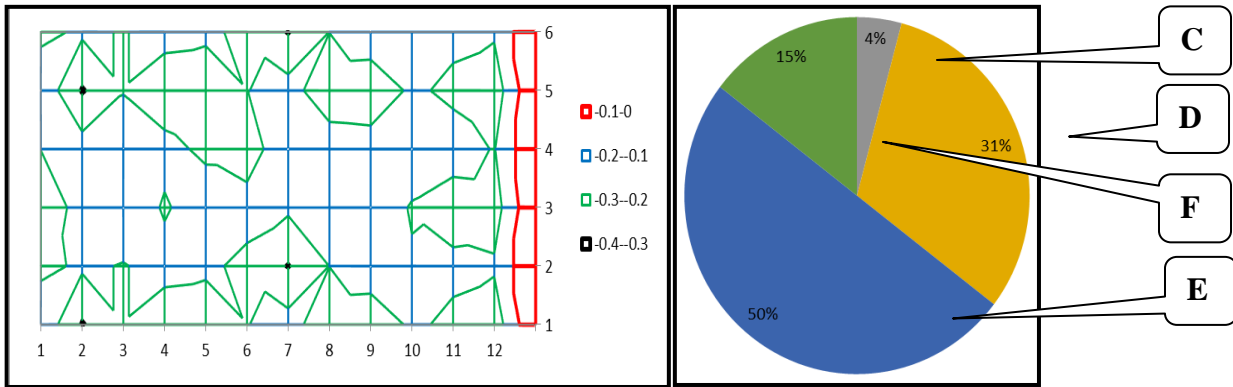
The Test results are presented as contour map (Fig. 12) and pie chart (Fig. 13). It is observed that 4% area falls under category 'C', 31% area falls under category 'D', 50% area falls under category 'E' and remaining 15% area falls under category 'F'.

Fig. 5 Contour Map Showing Corrosion Status of Scanned Area in Scanned Area

Fig. 6 Pie Chart Showing Degree of Corrosion

Referring Table 1 it is observed that in 35% area status of corrosion is uncertain while in remaining 65% area, 90% chances are that there is no corrosion activity at present.

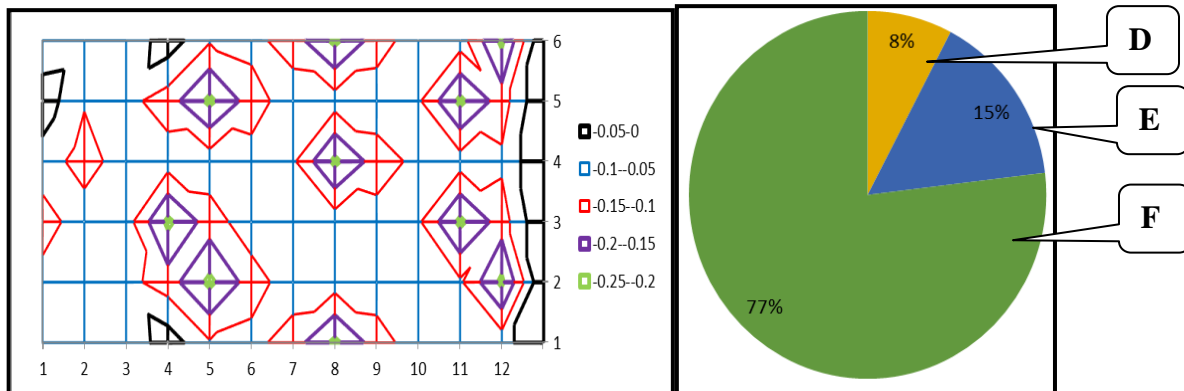
The Test results are presented as contour map (Fig. 14) and pie chart (Fig. 15). It is observed that 8% area falls under category 'D', 15% area falls under category 'E' and remaining 77% area falls under category 'F'.

Fig. 5 Contour Map Showing Corrosion Status of Scanned Area in Scanned Area

Fig. 6 Pie Chart Showing Degree of Corrosion

Referring Table 1 it is observed that in 8% area status of corrosion is uncertain while in remaining 92% area, 90% chances are that there is no corrosion activity at present.

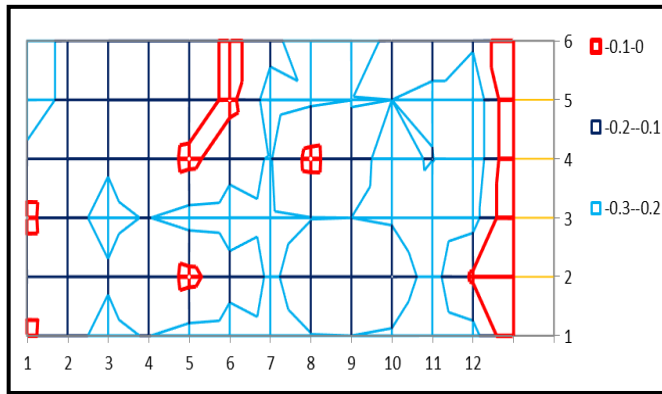
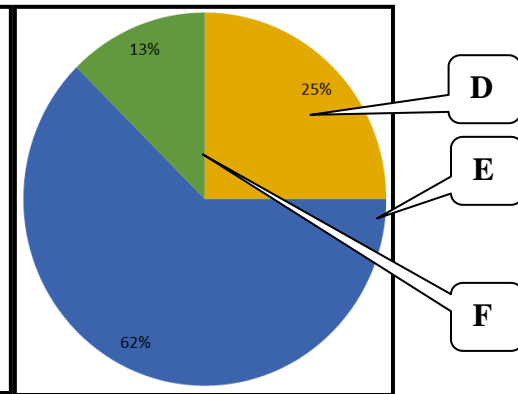
The Test results are presented as contour map (Fig. 16) and pie chart (Fig. 17). It is observed that 25% area falls under category 'D', 62% area falls under category 'E' and remaining 13% area falls under category 'F'.

Fig. 5 Contour Map Showing Corrosion Status of Scanned Area in Scanned Area

Fig. 6 Pie Chart Showing Degree of Corrosion

Referring Table 1 it is observed that in 25% area status of corrosion is uncertain while in remaining 75% area, 90% chances are that there is no corrosion activity at present.

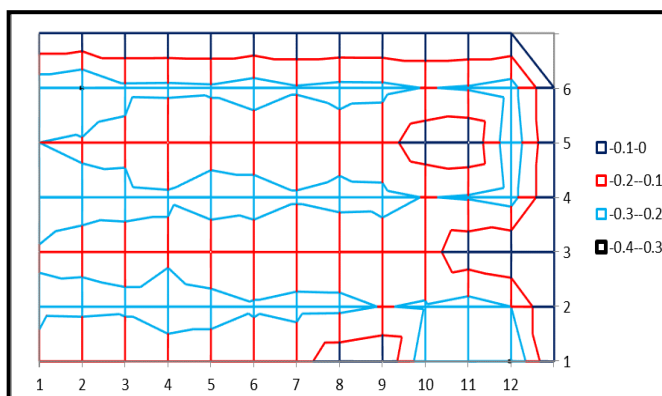
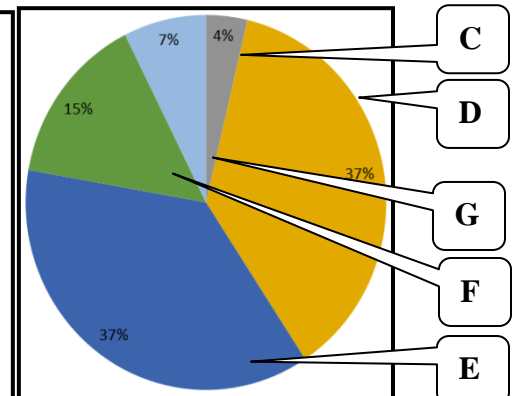
The Test results are presented as contour map (Fig. 18) and pie chart (Fig. 19). It is observed that 4% area falls under category 'C', 37% area falls under category 'D', 37% area falls under category 'E', 15% area falls under category 'F' and remaining 7% area falls under category 'G'.

Fig. 5 Contour Map Showing Corrosion Status of Scanned Area in Scanned Area

Fig. 6 Pie Chart Showing Degree of Corrosion

Referring Table 1 it is observed that in 41% area status of corrosion is uncertain while in remaining 59% area, 90% chances are that there is no corrosion activity at present.
