# Stability Analysis of Rock-Socketed Piles on Inclined Slope: Case Study on Conveyor Belt Foundations of Dangote Cement, Ethiopia

## Research Article

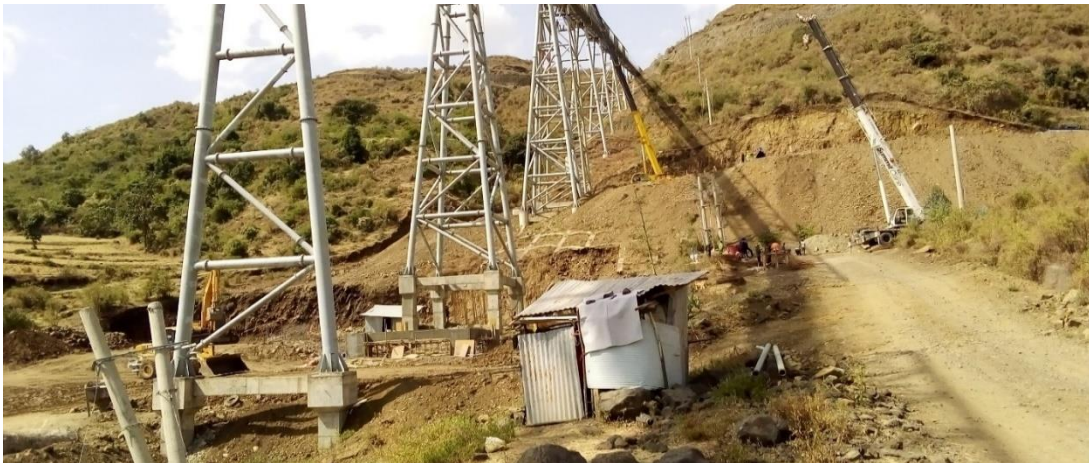
Figure 1. Conveyor belt of Dangote cement on inclined natural slope.

In this study, large diameter bored rock-socketed piles are being used to carry heavy loads from Conveyor Belt (Figure1). The total length of the Conveyor Belt is about seven kilometres for Dangote Cement Factory to quarry area in order to transport limestone from quarry to the Factory. The vertical, long, bored, end bearing and reinforced concrete pile were used for this study.

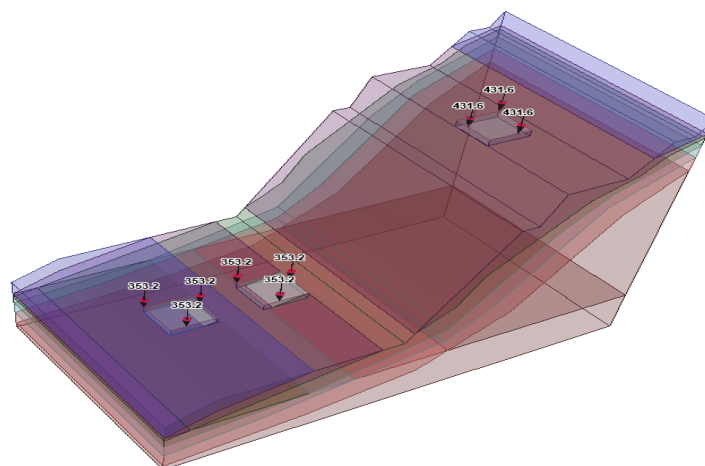
Figure 7. 3D load of the actual ground surface during uniformly distributed loads.

**Loading:** In modeling the gravity field stress type was used and the actual ground surface was considered during analysis. The load on the pile cap of the pile foundation was uniformly distributed loads as described in Table 6 and Figure7.
