# To Arrive At Solution for Profile Distortion Problem Encountered During Heat Treatment Process of Gear Manufacturing Using Root Cause Analysis

The present work is carried out at Oerlikon Fairfield where difficulty occurred while developing a new helical gear. Profile fall was evident post heat treatment process and this affected required gear accuracy. The difficulty is related to correction of profile distortion problem occurring post heat treatment. When gears are hardened, distortion problems lower the quality of the gears and this initiated for finding the root cause of distortion by using quality tools like Root Cause Analysis Techniques so as to eliminate distortion problem by finding the root cause. Generally Failure Mode Effective Analysis(FMEA), Cause and Effect Diagrams, Shainin Methodology, Plan do check act cycle (PDCA), DMAIC(define-measure, analyze -improve-control) methodology are effectively used in industries to attain solutions for problems encountered during part's processing.

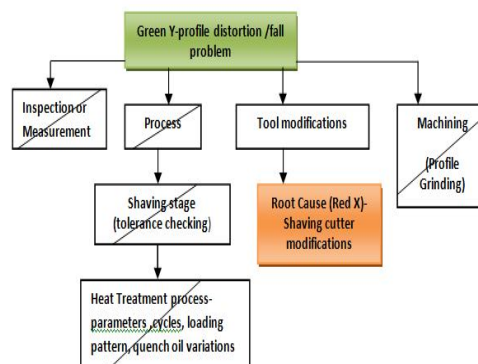
RCA-SHAININ METHODOLOGY

Shaving cutter modification , and hence modifications done in shaving stage was tried and successful results were attained.

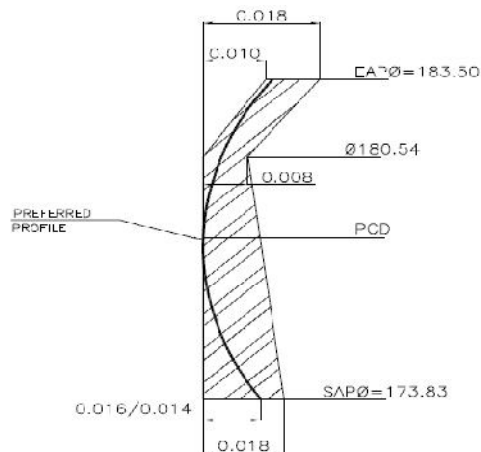
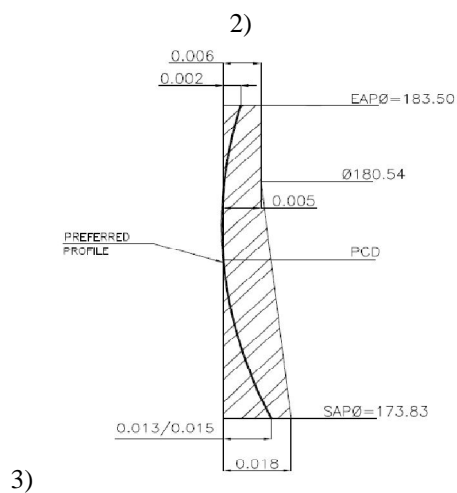
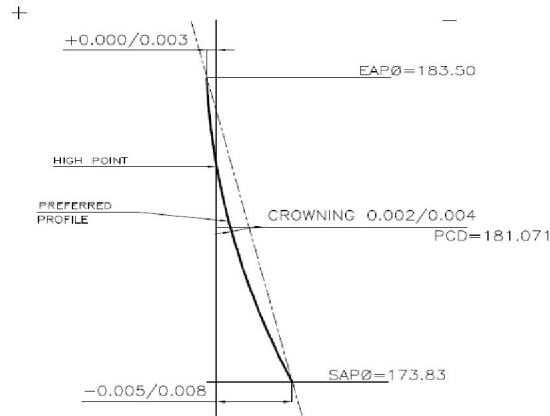
Changes in Shaving cutter's modification graphs along with gear's shaving graphs shown

The profile fall of shaved part always portrays the negative values. Hence correction was worked out on reducing the negative values during 1st modification of shaving cutter. Improved results were seen after 1st modification but further improvement was required and because of this requirement, the shaving cutter was modified for the 2nd time where negative values were changed to positive values. When external gears are shaved, the engaging tooth profiles of shaving cutter teeth and gear teeth are of convex surfaces. This understanding is vital so as to comprehend the shaving cutter modifications.

The cutter modifications with parts shaving stage graphs and Heat Treated parts graphs are shown for better understanding and analysis.

- 1) Initial shaving cutter-K sheet length from centre line is -0.018mm and cutter profile trace is -0.010mm (negative values)
- 2) After 1<sup>st</sup> modification of shaving cutter teeth profile shows -0.018mm changed to -0.006mm and -0.010mm to -0.002mm. (negative values, but improved)
- 3) After 2<sup>nd</sup> modification of shaving cutter teeth profile shows cutter profile trace changed to +0.002mm to +0.003mm. (positive values)
